**CBDC powered Smart PerFORrmance contractS for Efficiency, Sustainable,
Inclusive, Energy use**

D3.4 Report on the renovation technologies for each building and deployment approach M20

Report Identifier:	D3.4		
Work-package:	WP3	Task:	T3.2
Responsible Partner:	T.G. TECHNIKI MONOPROSOPI I.K.E. (TGT)	Version Number:	1.0
Due Date	31/05/2024	Document Date	21/10/2024
Distribution Security:	PU	Deliverable Type:	R
Keywords:	Renovations, Technologies, Construction, Energy renovations, Building Upgrade		
Project website: http://www.fortesie.eu/

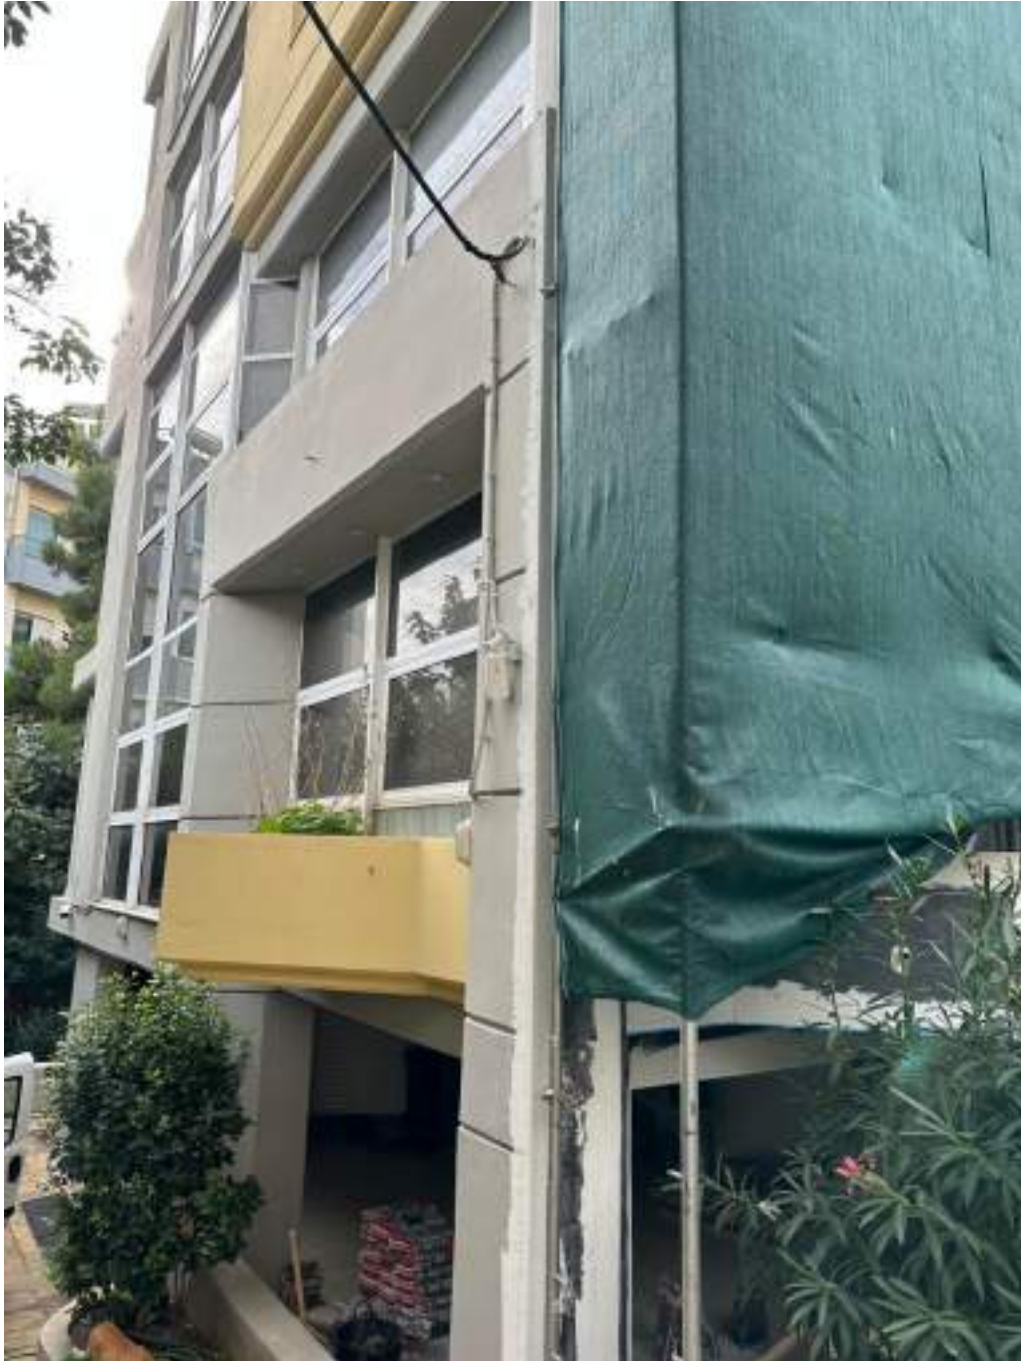
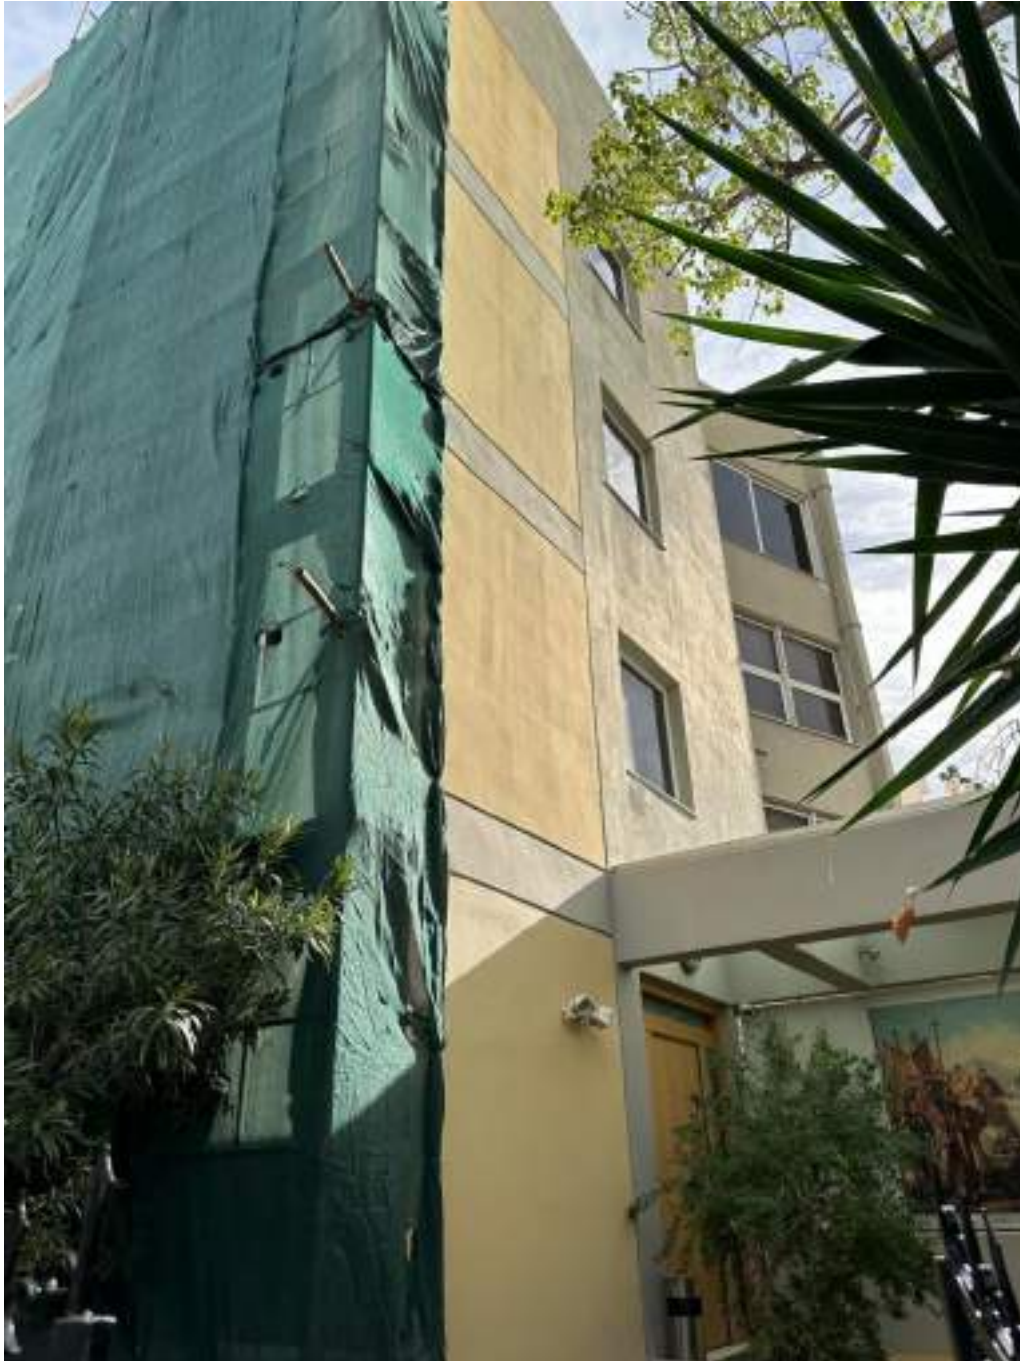
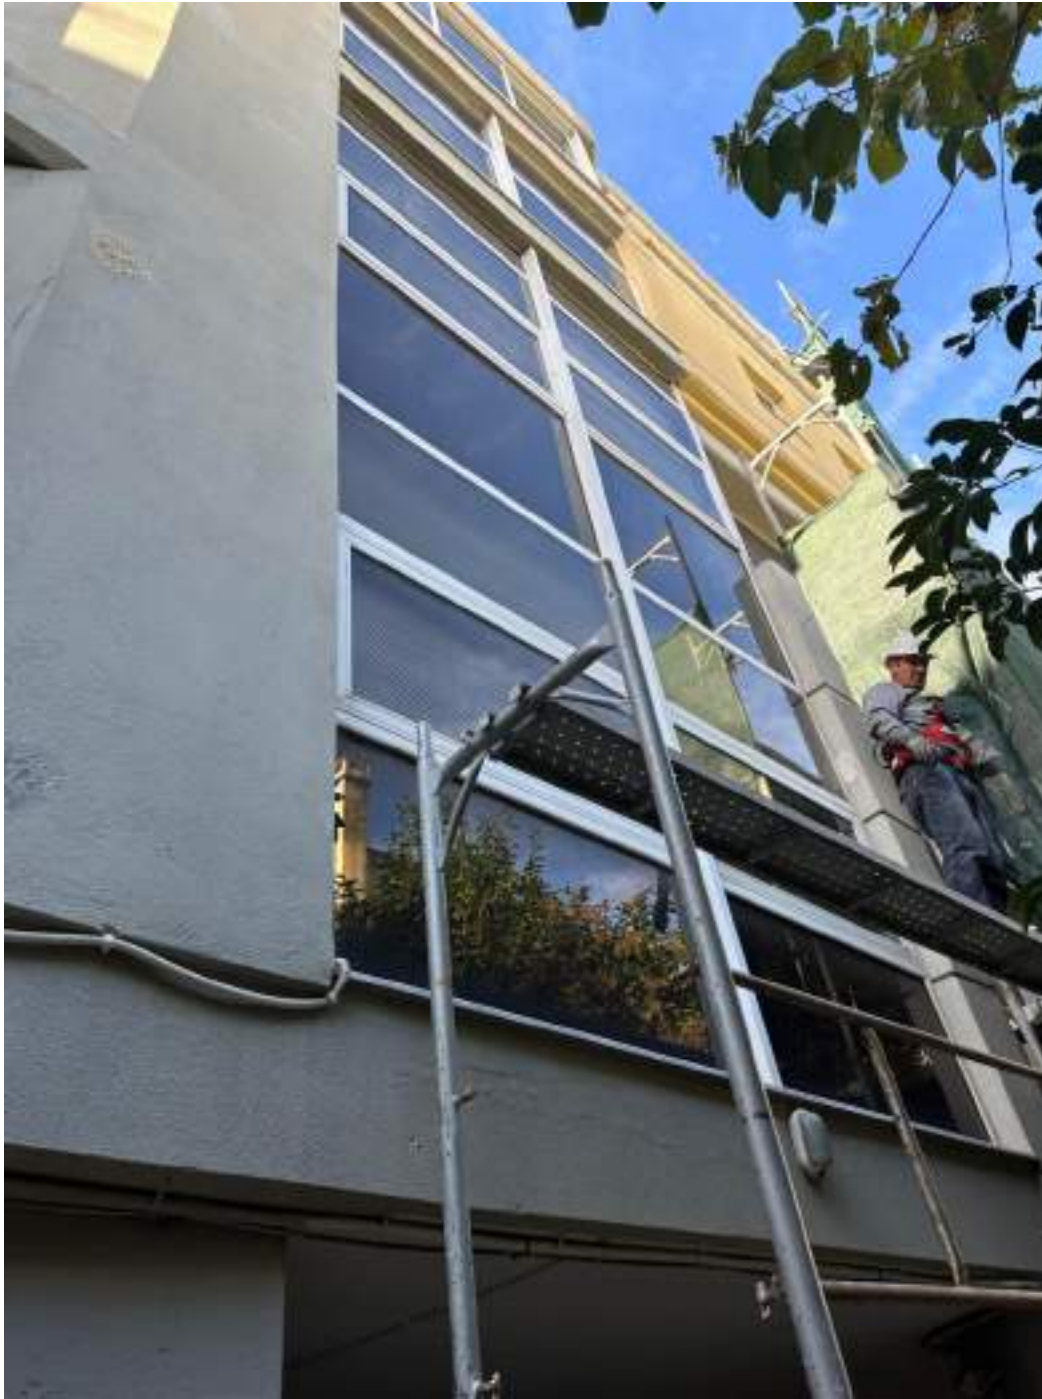
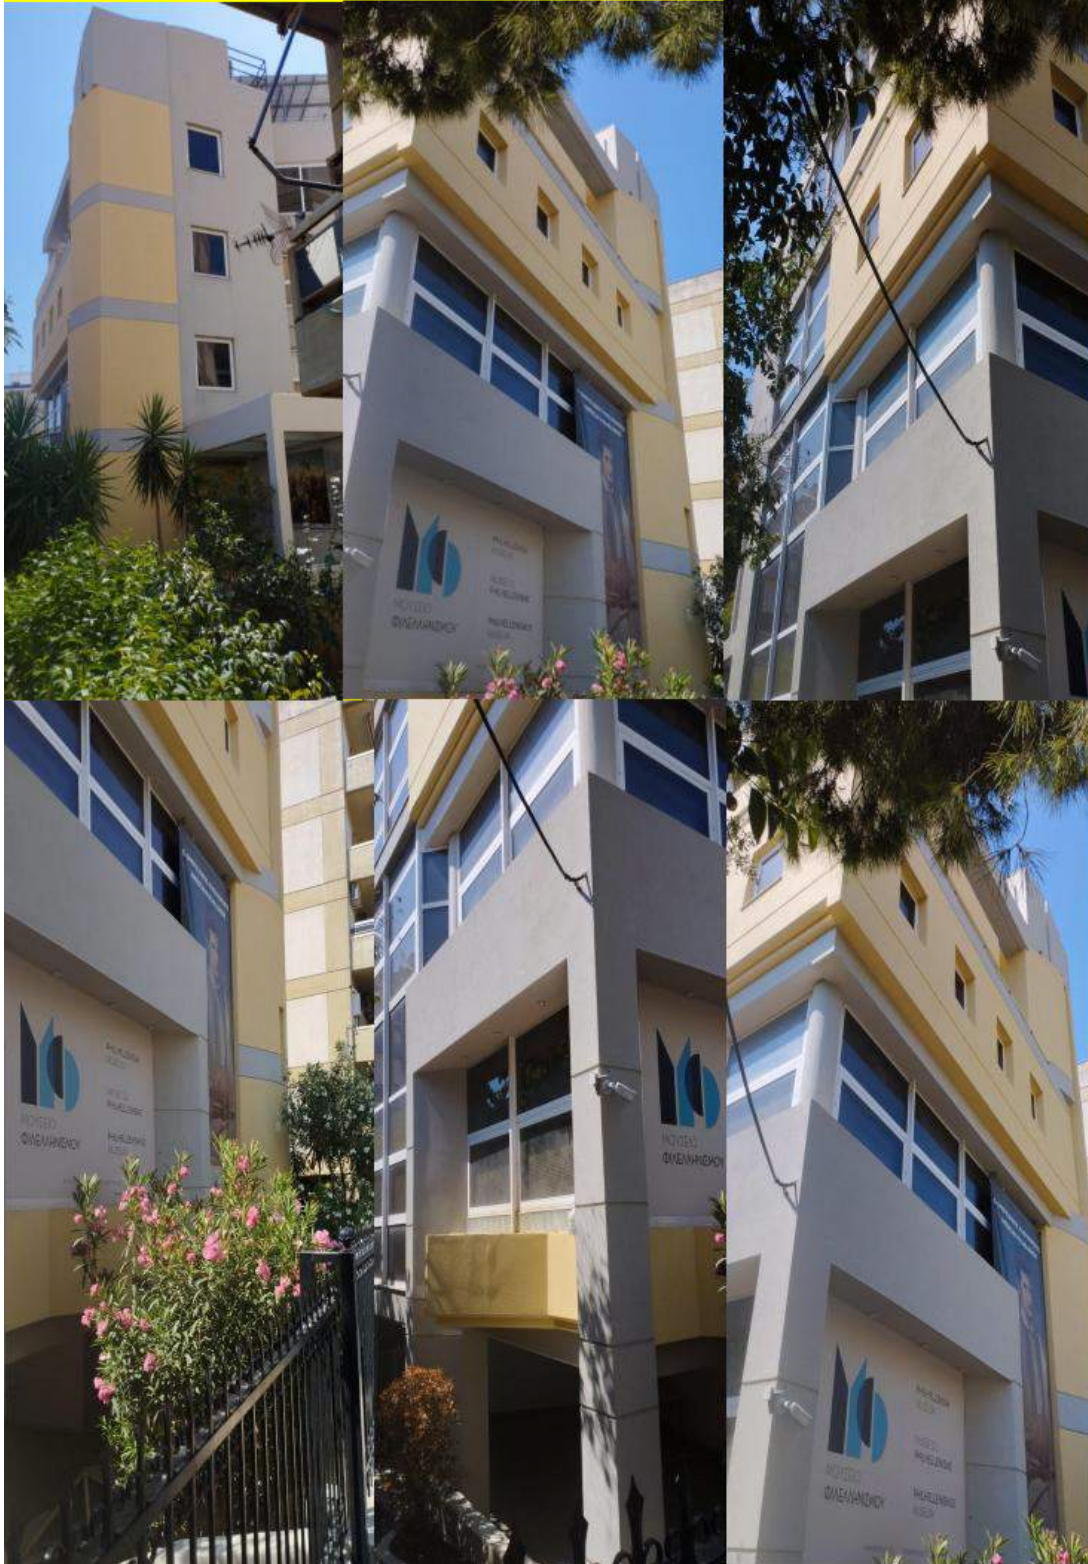
The examination of the building's overall insulation was found poor, negatively impacting energy consumption, humidity levels, temperature, and comfort. Although initially, it was planned to insulate only the north facade of the building, due to limited initial budget), it was found necessary to also insulate the north side of external wall part of the northwest facade, as it had no insulation, leading to significant energy wastage, humidity issues, and discomfort but also due to the building's design.

Figure 2 Museum Facade during and after the renovation 1.

Figure 3 Museum Facade during and after the renovation

Figure 4 Museum Facade during and after the renovation

Figure 5 Museum Facade after the renovation

As planned, the insulation took place by first checking the wall, cleaning, and drying it to ensure it is dust-free. The surface needed to be cleaned of paint and other substances that may affect/negatively impact the performance of EPS facade. First a penetrating water-based primer was applied. The primers took approximately 4 hours to dry. However, additional coats were required to ensure absorptivity of the substrate. Materials used for the insulation were EWI-301 Water-Based Substrate Primer (5 liters), EWI-310 Universal Primer (20 liters) and Surface Preparation Substrate Suitability Check Surface Priming. Once the walls were primed, starter track needed to be installed. The starter track was attached to the substrate above the DPC. This not only provided a level surface for easy installation of the insulation; and protected the bottom of the surface of the insulation against weather, damp, and other damage. The EPS insulation boards were attached to the substrate with adhesives. The correct preparation of EPS adhesive was crucial and for that the compound was mixed using a heavy-duty power plaster mixer on a slow-rotating setting. A freshly mixed compound was left for approximately 5–10 minutes and then re-mixed for a short period of time before use. The EPS adhesive needed to be applied to the perimeter of the EPS board, and 3 large dabs were applied in the centre of the board. To ensure the EPS insulation boards are aligned properly when attached to the substrate they needed to be aligned correctly both horizontally and vertically, and this is best achieved using a spirit level. Gaps between the EPS boards and these are larger than 2mm, they were filled with polystyrene strips (cut from the insulation boards). Drilling the holes for fixings took place at least 2-3 days after the EPS boards have been attached to the substrate with the EPS Adhesive and prior to adding the reinforcing fiberglass mesh layer. When installing EPS insulation around window and door openings, it is important that the joints between boards are not in line with these openings. This would prevent cracks from appearing in the future. The surface of the EPS boards must be smooth and level throughout the facade. All uneven areas were made smooth prior to applying the reinforcement layer. Smoothing of EPS boards should take at least 1-2 days after they have been installed to ensure the EPS Adhesive had sufficient time to go off. Once the render has been applied, it was smoothed out using the trowel, taking out the excess off the wall (to ensure an extremely thin layer). Using a PVC float, the render is worked by moving it in circular movements; this will provide the textured finish of the render.

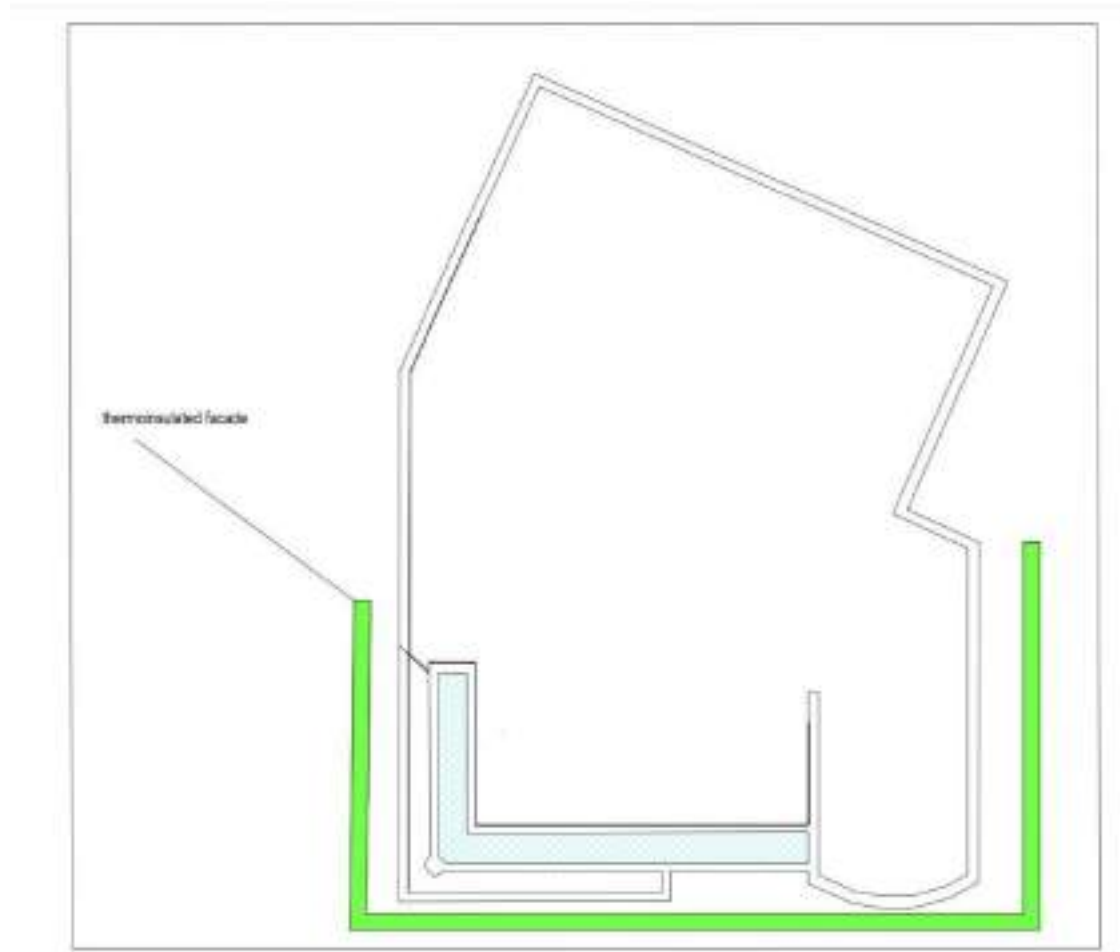
Figure 6 Museum Facade insulation area

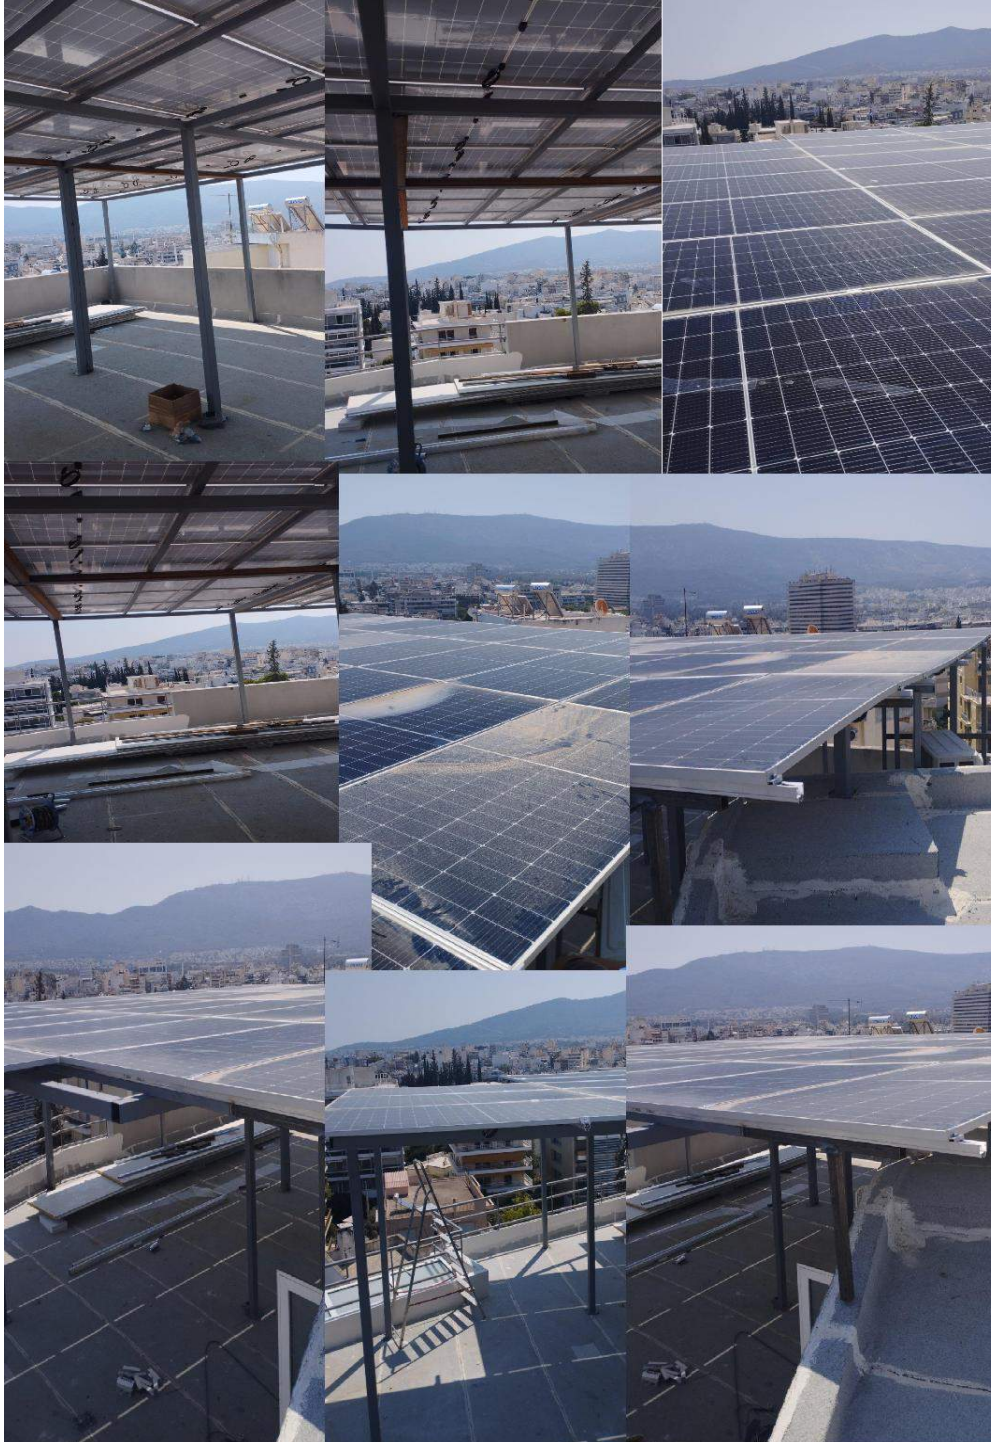
Figure 8 Pergola instalment

The PVs were installed in specialised aluminium basis appropriate for solar panels.

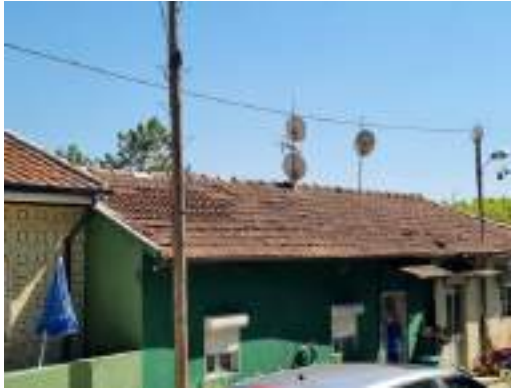
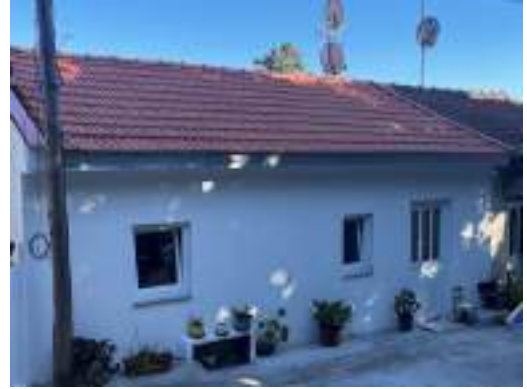
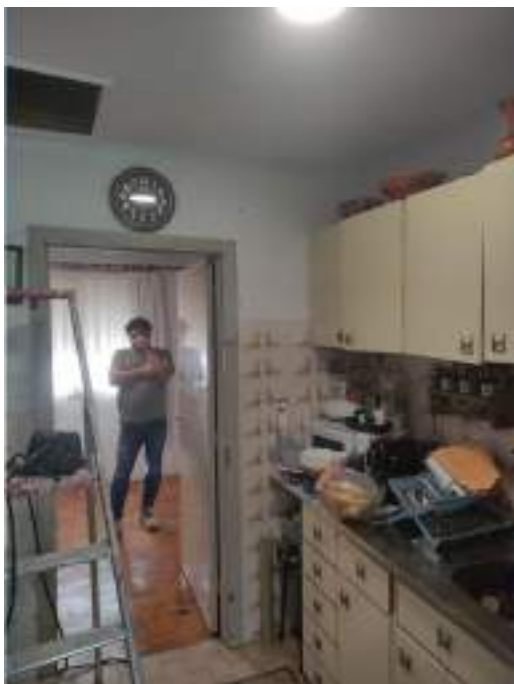
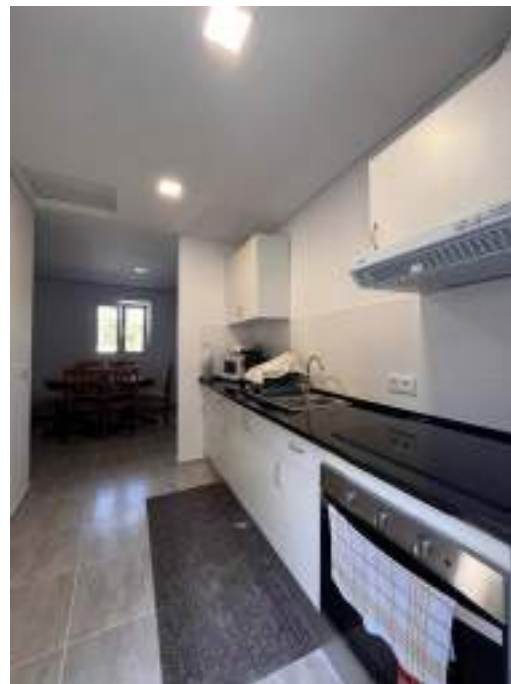
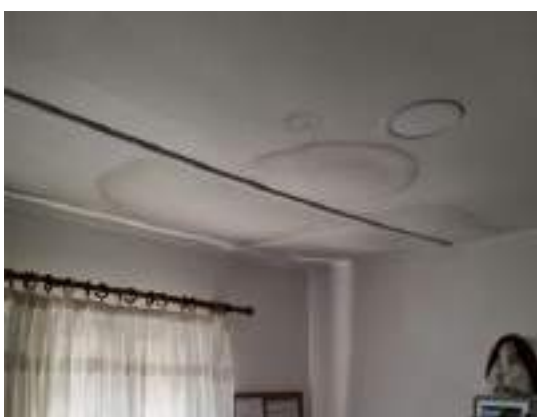
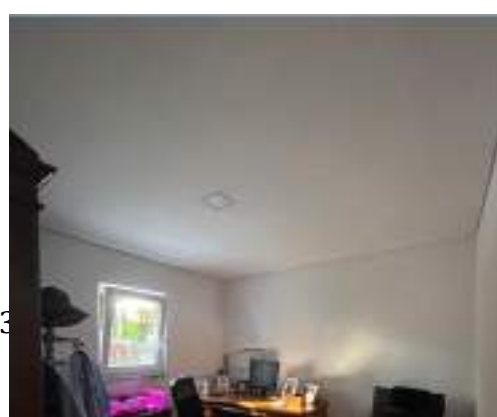
Figure 10 House n. 1 - Porto before

Figure 11 House n. 1 - Porto after

Figure 12 House n. 1 - Porto Before

Figure 13 House n. 1 - Porto After

Figure 14 House n. 1 - Porto Before

Figure 15 House n. 1 - Porto After

Description of done (if done) and/or plans of remaining work (if not done),	<ul style="list-style-type: none"> ● Installation of certified scaffolding ● Reinforcement of the roof structure and complete replacement of roof tiles ● Removal of the asbestos-cement roof from the annex ● Installation of a new sandwich panel roof on the outbuilding ● ETICS exterior wall cladding ● Repair of the entire electrical circuit ● Installation of a fully equipped bathroom inside the house ● Laying ceramic flooring in the bathroom ● Installation of hot and cold water pipes in the new bathroom ● Creating a plasterboard partition for the new bathroom ● Covering the walls of the new bathroom with tiles ● Installation of a plasterboard ceiling throughout the house (with rock wool thermal insulation) ● Installation of 1 exterior door and 4 windows ● General painting of interior walls and ceilings and exterior walls ● Installation of an equipped kitchen

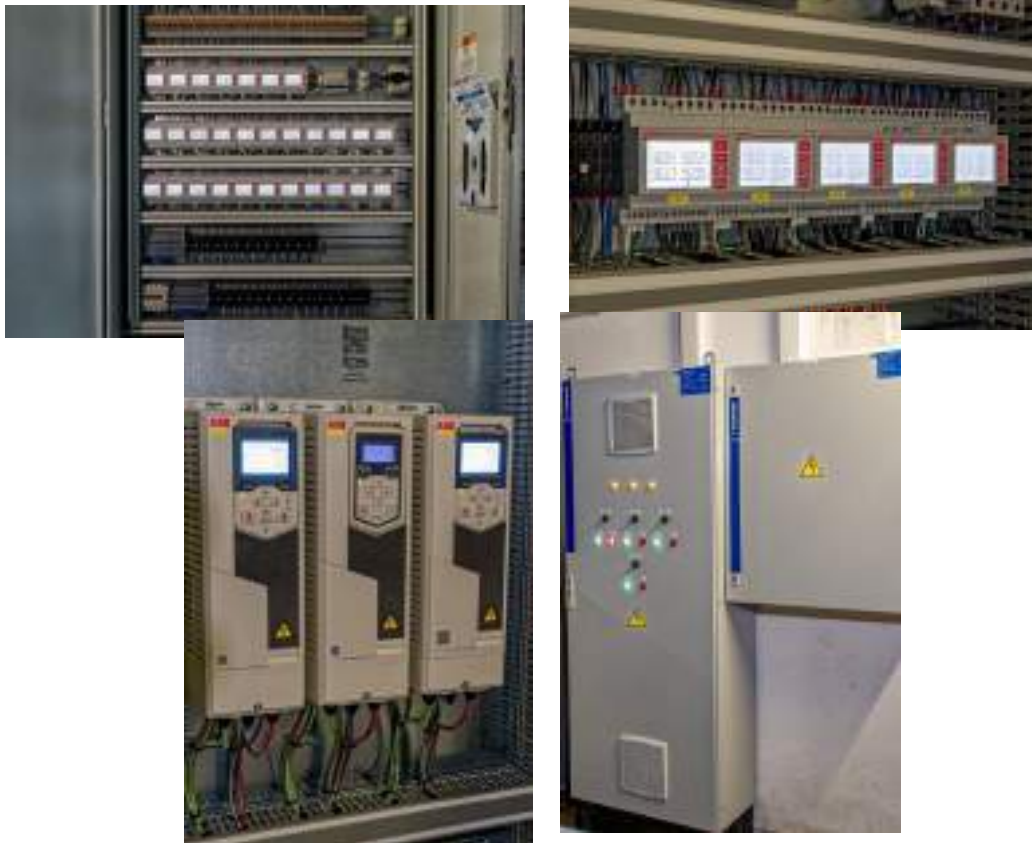
Figure 16 Panels after the energy meters and inverters

- 128 energy consumption meters were installed in most of the electrical panels of the building to record and visualise the desired electrical quantities. The points of interest for consumption measurement concern loads such as Central Air Conditioning Units and specifically their fans, ventilation fans, heat exchangers, pumps (water, boiler heating, cold and hot pumps, etc.), hot water heater.

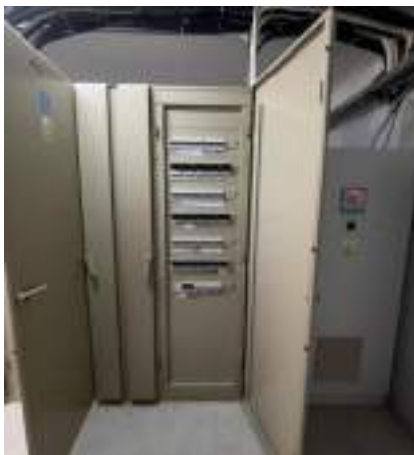
Figure 17 Existing main electrical switchboard

1. The photo shows the existing main electrical switchboard, which is set to be modernised in accordance with the technical and execution project. The planned upgrades include replacing the distribution circuits that supply the TN1/W1, TN2/W2, 01/TO2, 01/TS6, and 01/TS2 electrical panels, as well as installing a power circuit for the newly designed RBMS switchboard and the PV system inverter. Additionally, the main switchboard will be equipped with a PowerLogic network parameter metre and PowerTag measurement transducers on selected outgoing circuits. These changes are necessary to enhance the efficiency and reliability of the electrical system, accommodate new energy sources, and improve monitoring capabilities. The modernization process will involve several stages, including the removal of outdated components, installation of new circuits and equipment, and thorough testing to ensure optimal performance. These renovations contribute to making the building more energy-efficient by optimising energy distribution, reducing losses, and enabling better control and management of energy consumption.

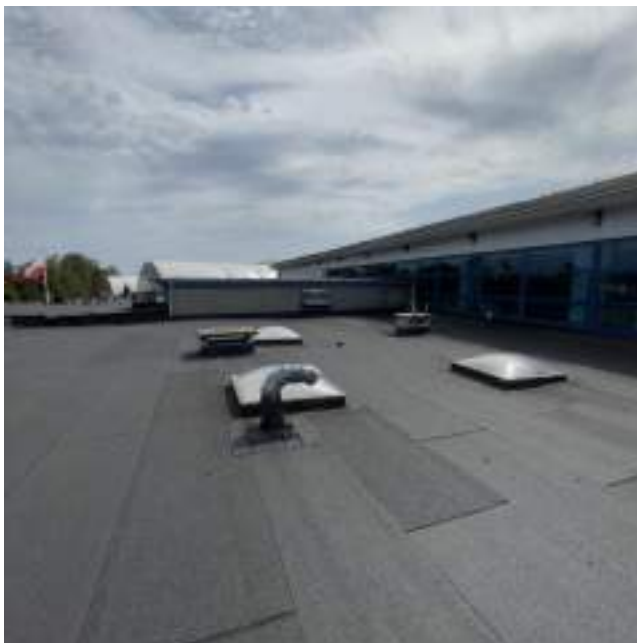
Figure 18 Pool rooftop

2. The photo shows the rooftop where a photovoltaic installation will be installed according to the technical and execution project. The photovoltaic modules will be mounted on a dedicated mounting structure and then connected to the inverter using double-insulated cables resistant to UV radiation and varying weather conditions. The inverter will be installed on the roof and paralleled with the building's existing electrical installation using an AC-rated cable. The entire installation will be equipped with appropriate protections on both the AC and DC sides. Before the photovoltaic panels are installed, the roof covering will be reinforced by using Styro boards under the mounting feet of the panels and layers of roofing felt, in accordance with the project guidelines. These changes are necessary to ensure the stability and durability of the photovoltaic installation. The stages of the renovations include reinforcing the roof covering, installing the mounting structure, connecting the photovoltaic modules to the inverter, and integrating the system with the building's electrical installation. These steps contribute to making the building more energy-efficient by allowing it to generate its own renewable energy, reducing reliance on external power sources and lowering overall energy consumption.

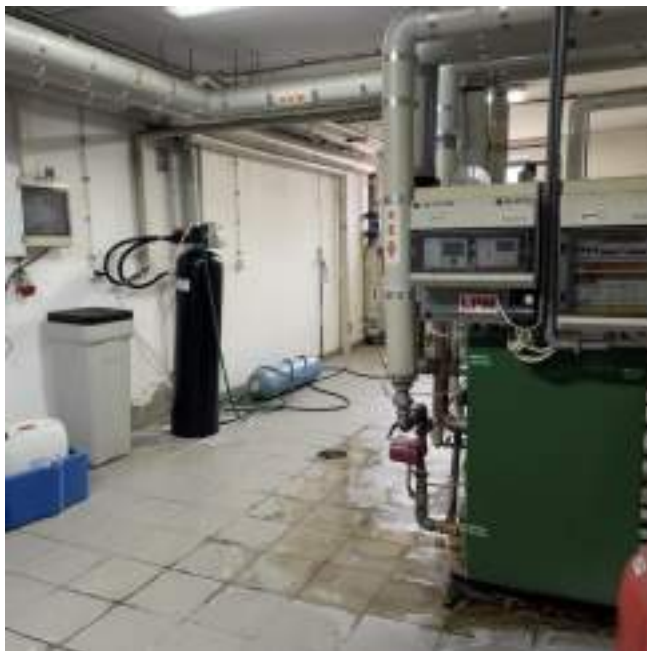
Figure 19 Heating substation room

3. The photo shows the heating substation room, which will undergo renovation according to the technical project. The wall layout will remain unchanged, with equipment and installations updated based on detailed designs. The flooring and tiling will be replaced with a technical floor painted in RAL3000. Existing lighting fixtures will be upgraded to IP65-rated LED lighting, and switches and sockets will also be replaced with IP65-rated versions. The current sanitary ceramics will be evaluated and, if necessary, replaced with new industrial-standard fixtures. The project includes the

installation of a DN80 connection substation featuring a magnetic dirt separator (OISm 250/80), two FS-1 80 filters, a constant differential pressure regulator with flow control (Samson 42-39 DN50, $kvs=32.0$ m³/h), and a Kamstrup Ultraflow 54 DN65 flanged water meter ($qp=25.0$ m³/h, PN25). The central heating substation will be equipped with a compact Danfoss Poland unit, which includes a brazed plate heat exchanger (Danfoss XB12M-1-36, 36 plates, 0.4 mm thickness, AISI 316 stainless steel), a Grundfos MAGNA3 25-60 electronically controlled pump, and a Reflex N 100 diaphragm expansion vessel. Additionally, a membrane safety valve (SYR 1915, 1", 0.50 MPa) will be installed on the heat exchanger's outlet. For domestic hot water, a Danfoss Poland compact substation with a brazed plate heat exchanger (Danfoss XB52M-1-50, 50 plates, AISI 316 stainless steel) and a Grundfos MAGNA3 25-60 N electronically controlled pump will be used, along with a membrane safety valve (SYR 2115, 1", 0.6 MPa). These renovations are necessary to enhance the building's energy efficiency, improve reliability, and ensure compliance with modern standards. Each stage of the renovation, from updating flooring and lighting to installing advanced heating and water systems, contributes to creating a more energy-efficient and reliable heating infrastructure.

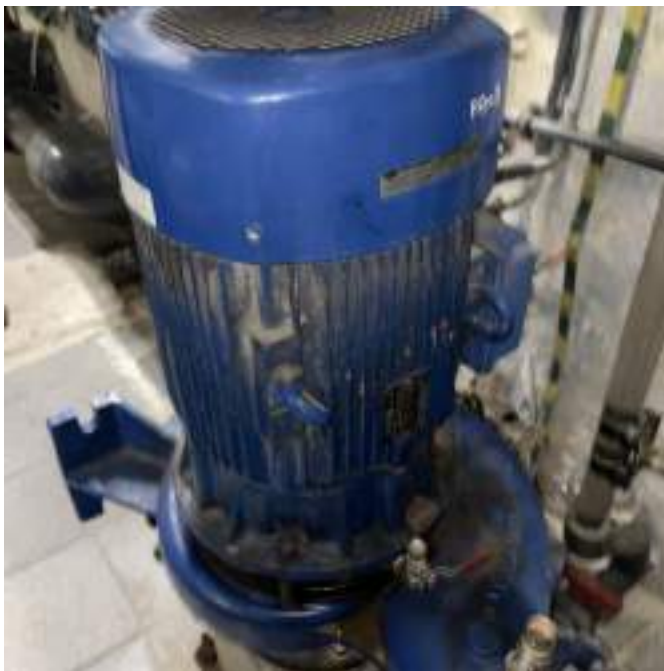
Figure 20 Water circulation pump for the pool water treatment system

4. The photo shows the existing water circulation pump for the pool water treatment system, which will be replaced as part of the project. This replacement involves updating the existing circulation pumps and associated power cables, as well as installing new frequency converters for the pump motors. The installation and wiring of the equipment will follow the specifications outlined in

drawing 01 – Pool Technology Equipment Layout. Electrical cables will be laid in cable trays, and power for the pumps will come from the existing power distribution cabinet. All existing power cables for the circulation pumps will be replaced with YDY 4x4mm² cables between the power cabinet and the frequency converters, and TOPFLEX EMV 4x4mm² shielded cables between the converters and the pump motors. The old circulation pumps will be dismantled and disposed of, to be replaced with new pumps that have identical mounting dimensions but higher efficiency motors, such as the HERBORNER PUMPEN UNIBLOCK-GFC 125-250/1104GFC-W2 or an equivalent model. The new pump will feature a horizontal centrifugal design with the option for vertical mounting, internal circulation for mechanical seal washing, and a three-phase motor with water jacket cooling. The motor will also have IP55 protection, reinforced bearings, and a stainless steel shaft, along with PTC temperature sensors and grease fittings for easy maintenance. The technical specifications for the new pump include a capacity of 100.0 – 280.0 m³/h, a head of 18.0 – 10.0 m, a voltage of 400/690V, a motor power of 11.0 kW, a speed of 1450 rpm, and a nominal current of 20.9 A. Additionally, frequency converters such as the INVERTEK OPTIDRIVE E3 or an equivalent model will be installed on the wall in the pump room, with IP66 protection. These converters will have an input voltage of 380-480V ±10%, a supply frequency of 48-62 Hz, a phase shift factor greater than 0.98, an overload capacity of 150% for 60 seconds or 175% for 2.5 seconds, and an output frequency range of 0-500 Hz. The control method for the converters will include scalar U/F with energy optimization, supporting both analog and digital input signals.

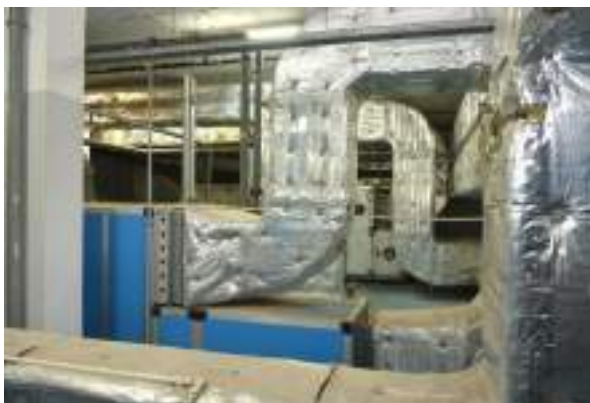
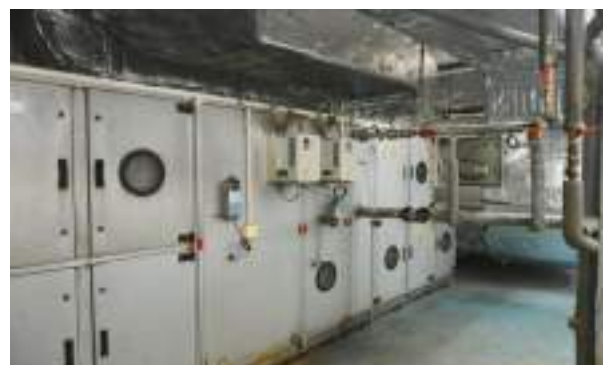
Figure 21 Existing air handling unit (AHU)

5. The photo shows the existing air handling unit (AHU), which will be replaced as part of the modernization project. This AHU maintains air quality and climate control in the pool areas. The new AHUs NW1 and NW2 will replace the old systems to ensure optimal operation and reduce operating costs. The current system will be replaced with modern units that will improve efficiency by 20%. The new units feature integrated automation, a heat pump, and a heat recovery exchanger for high energy efficiency. The existing system does not adequately control humidity and temperature, leading to condensation, corrosion, and potential structural damage. The new units will prevent these issues, protecting the building's integrity. The renovation includes dismantling the existing units and ductwork, followed by installing the new NW1 and NW2 units. These units were chosen for their higher efficiency and capacity to meet increased ventilation needs. They will be integrated with the building's automation system for better control and monitoring. The new AHUs will enhance energy efficiency by increasing airflow by 20%, allowing more effective ventilation. The heat recovery exchangers will use exhaust air to preheat incoming air, reducing energy consumption. Integrated automation will optimise operation, and better insulation (class T2) will reduce heat losses. The NW1 unit will have a maximum supply air volume of 18,080 m³/h with a static pressure of 550 Pa and a PSFP of 1.244 kW/m³/s. The maximum exhaust air volume will be 19,000 m³/h with a static pressure of 550 Pa and a PSFP of 1.122 kW/m³/s. The dimensions of the NW1 unit are 2085 mm (width), 5360 mm (length), and 2965 mm (height). It will maintain the pool hall temperature at 30°C year-round with a relative humidity of 55% in winter and 60% in summer. The plate heat exchanger will have an efficiency of at least 80%. The NW2 unit will have a maximum supply air volume of 11,760 m³/h with a static pressure of 550 Pa and a PSFP of 1.122 kW/m³/s. The maximum exhaust air volume will be 12,350 m³/h with a static pressure of 550 Pa and a PSFP of 1.122 kW/m³/s. The dimensions of the NW2 unit are 1445 mm (width), 4860 mm (length), and 2325 mm (height). Both units will feature integrated factory automation, a reversible heat pump, and an asymmetrical heat recovery exchanger made of polypropylene or anodized aluminium. The new units will meet all required standards for thermal insulation (class T2), thermal bridges (class TB1), airtightness (class L1), mechanical strength (class D1), and filter mounting tightness (class F9), as confirmed by certification from an independent body such as TUV.

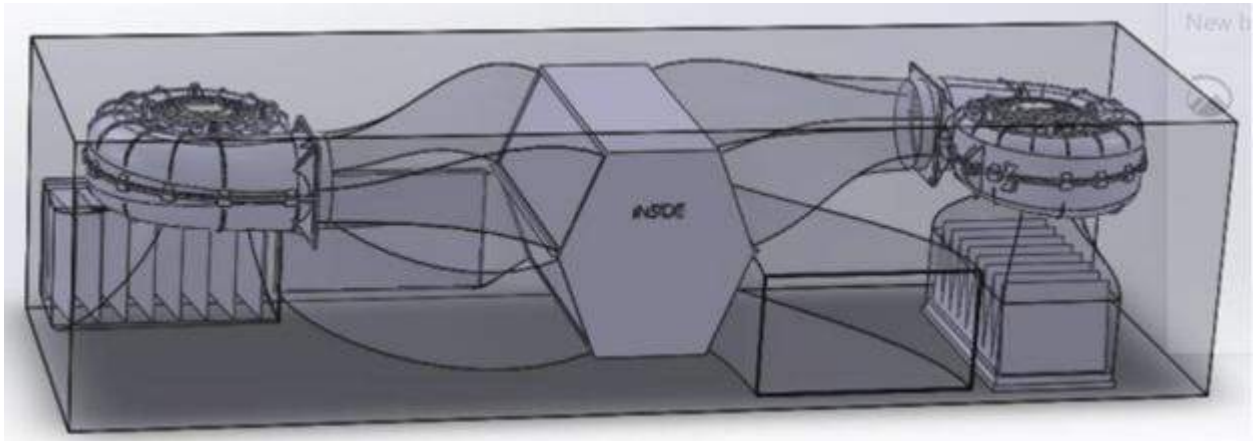
Figure 22 MESH air handling units

Everything is implemented according to plans.
